Coastal Erosion Project

Diani Beach, Kenya

May – June 2006

Delft University of Technology

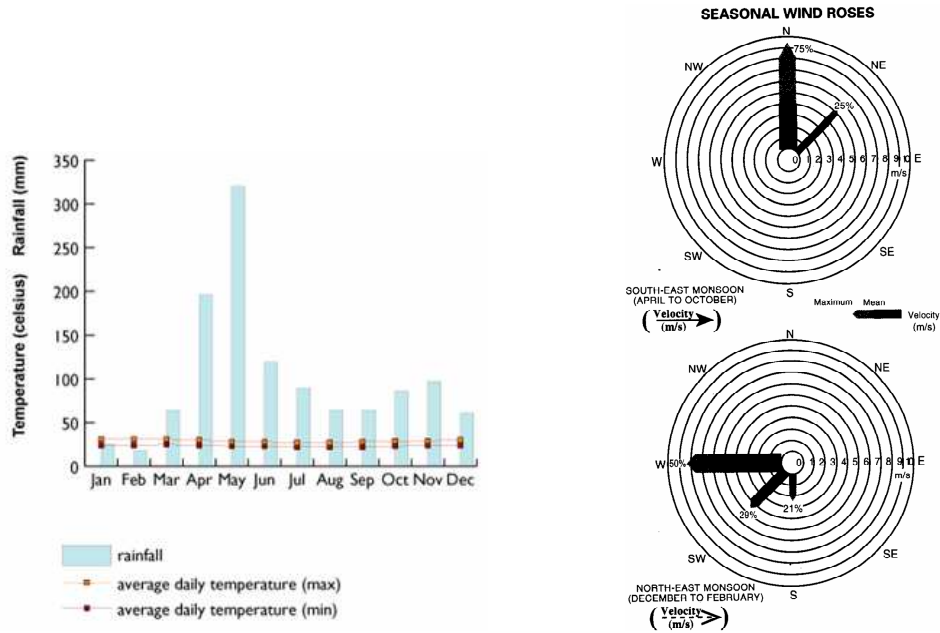
Figure 5-1: Rainfall in Mombasa and Seasonal wind roses for the Port of Mombasa¹

Figure 5-1 shows the precipitation in Mombasa throughout the year, clearly indicating two rainy seasons corresponding to the monsoons. Also the wind direction changing with the seasons can be seen.

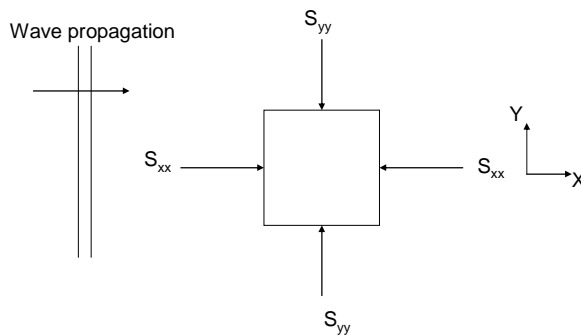
Figure 5-9: Radiation stress

The magnitude of the radiation stress depends mainly on the wave height via wave energy ($E \sim H^2$). In shallow water wave breaking processes therefore determine in a great extent the gradient of wave energy. A gradient develops in the radiation stresses and causes wave set-up and set-down.

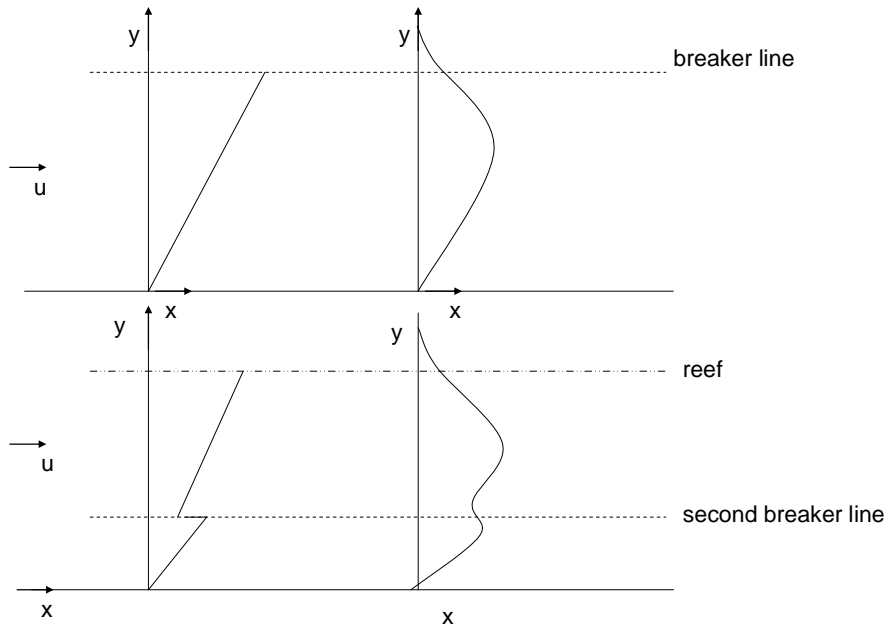
Figure 5-12: Longshore current due to breaking

In case of a breaker bar, like a fringing reef, waves can break twice. See Figure 5-12.

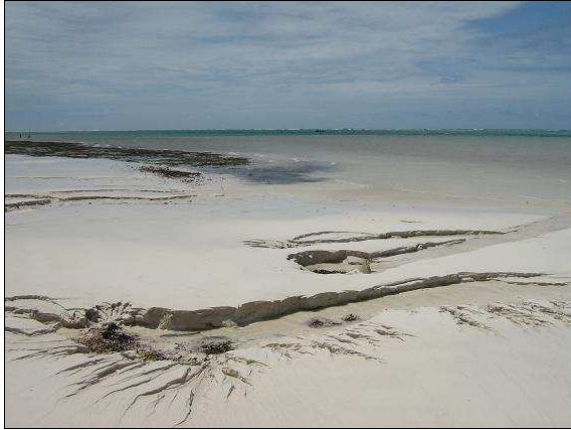
A rather unusual small scale form of sediment displacement is the occurrence of small wells on beaches during the lowering of the tide. The ground water level is high after a period of flood, but cannot keep pace with the lowering of the tide. Water pressure increases and wells of water occur sporadically, draining the surplus of water from the beach. These wells generate small currents which locally carry beach sediment towards the foreshore, see Figure 5-14.

Figure 5-14: Beach well occurring on Diani Beach. Photo: CF57

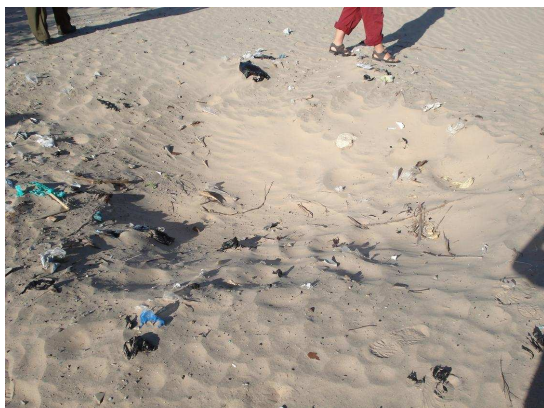
Figure 5-19: Small scale sand mining in Malindi. Some holes are visible. Photo: CF57

During some of our interviews (see Appendix V-H and V-L), sand mining was mentioned in relation to coastal erosion. It was concluded however that sand mining takes place, but the amount is indefinite.

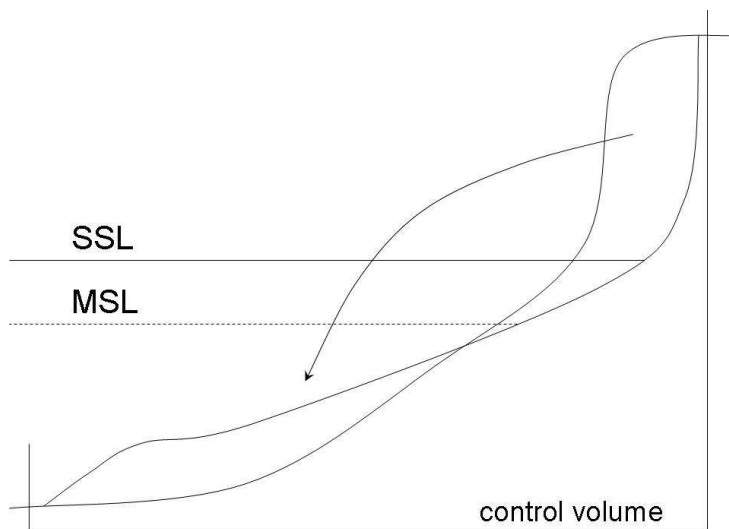
Figure 6-1: Redistribution over cross-shore profile. No loss of control volume.²

During high tides and storms the beach profile is reshaped. As shown in Figure 6-1, sediment from the (under normal conditions) dry parts is transported to the wet foreshore. This is visible on the beach head. However, in a stable condition sand is not removed from the control volume and the profile recovers gradually. Cross-shore transport returns the sediment to the dry parts of the coastal profile.¹

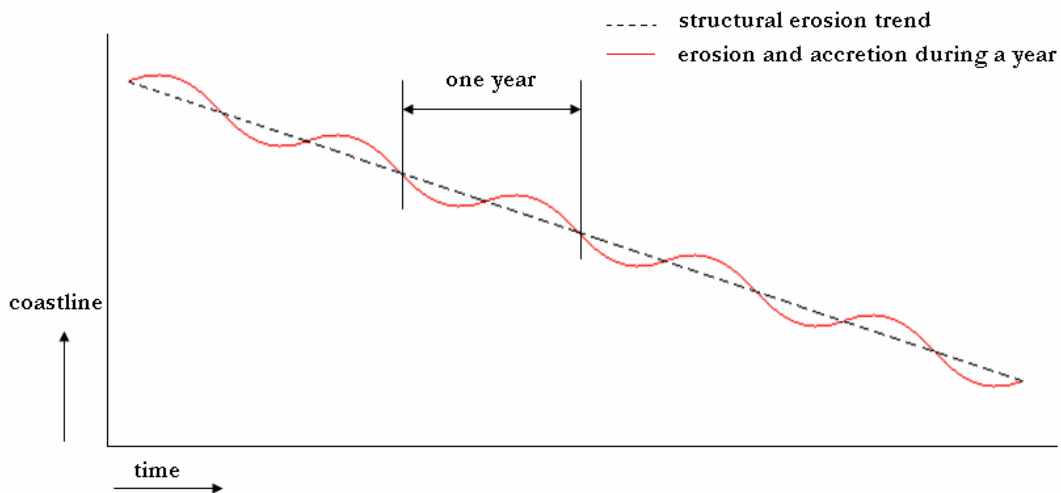
Figure 6-3: Structural and annual erosion

In the Diani area, erosion and accretion occur in a cycle with a period in the order of a few months. This can be attributed to the different seasons (see paragraph 5.1.4), the accompanying changing currents and local topography such as cliffs and reef platforms. This small scale cycle combined with the structural erosion of the Kenyan coast gives a net erosion rate shown in Figure 6-3. This figure is highly schematical.

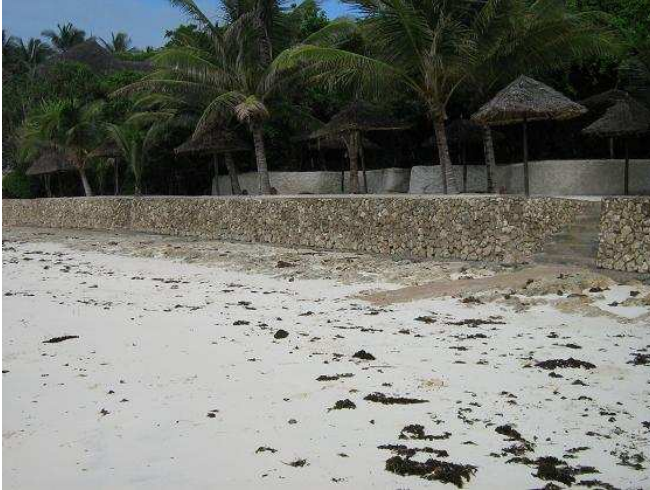
Figure 6-4: Leopard Beach Hotel in April. During the following months the entire beach will erode. Photo: CF57

A clear example of the above mentioned phenomenon occurs at the beach in front of Leopard Beach Hotel. It yearly erodes from April up to September (see Figure 6-4), before being replenished from October until January.

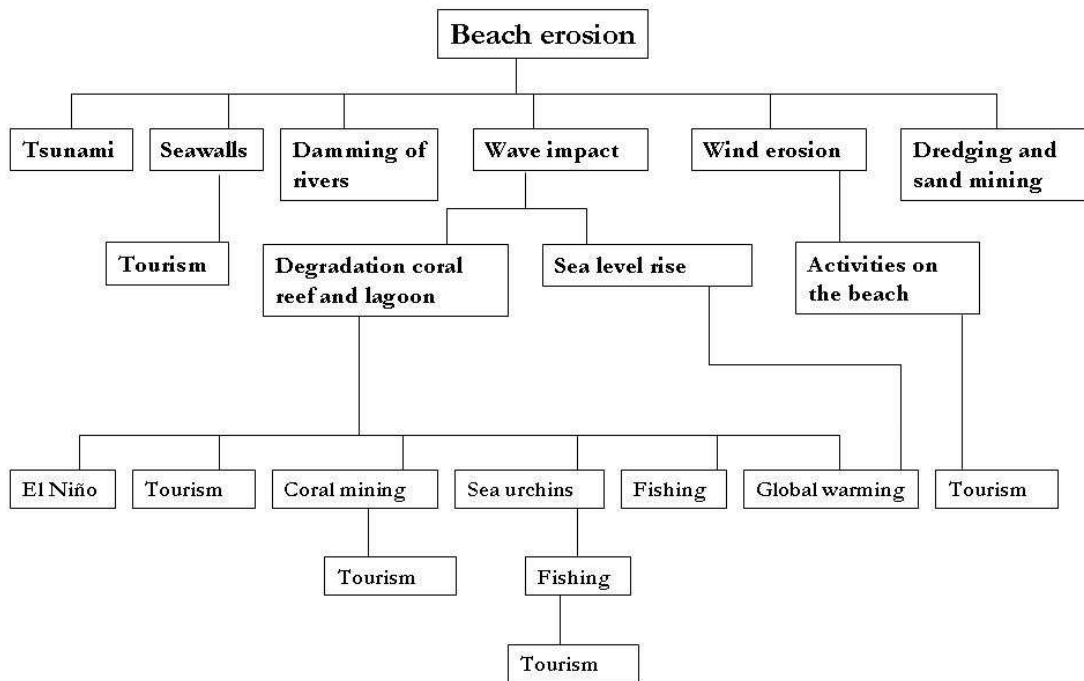
Figure 6-10: Relation diagram for the causes of erosion, as elaborated in Chapter 6

An overview of the causes and their relations can be found in the diagram of Figure 6-10.

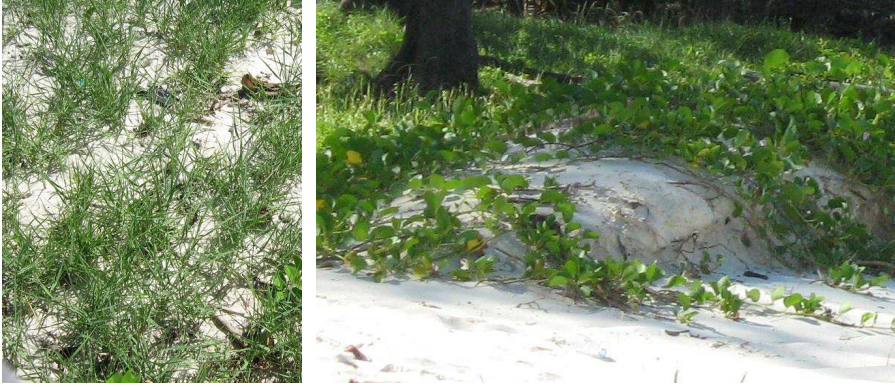
Plain grass types that withstand relatively high salinities are suitable vegetation on the dry foreshore. They can be found in various places in Diani Beach, see Figure 7-5a. Also a kind of ivy can be spotted on the beach head (Figure 7-5a). It is a low-growing creeping plant, which seems to have a sand retaining effect. It will certainly not prevent the beach from eroding, but it could diminish the erosion rate.

Figure 7-5: a) Plain grass, b): Kind of ivy

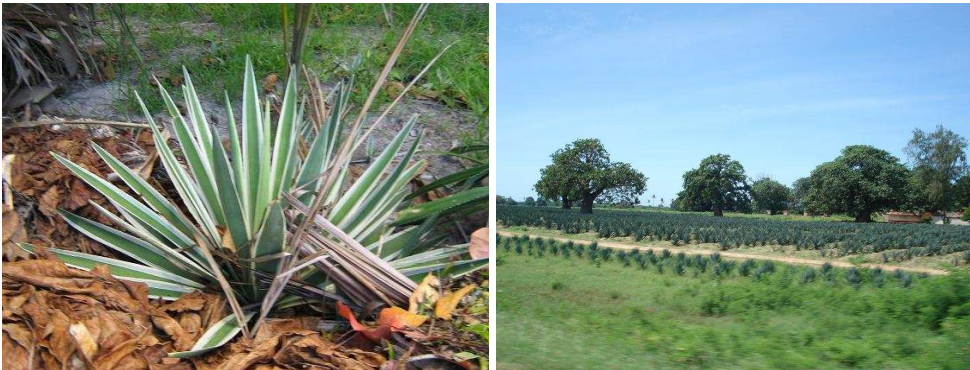
Not very commonly used vegetation for the protection of land is sisal, see Figure 7-6a. It is currently being used on a very small scale in Diani (see Appendix V-F). Large sisal plantations (Figure 7-6b) are located near Kilifi, north of Mombasa. The sisal plant can withstand harsh circumstances and grows rather close to the sea. It has a major root system consisting of long, thin strands. There has been no research on its sand retaining effect, but residents are positive on its effectiveness.

Figure 7-6: a) Sisal plant in Diani, b) Sisal plantation in Kilifi

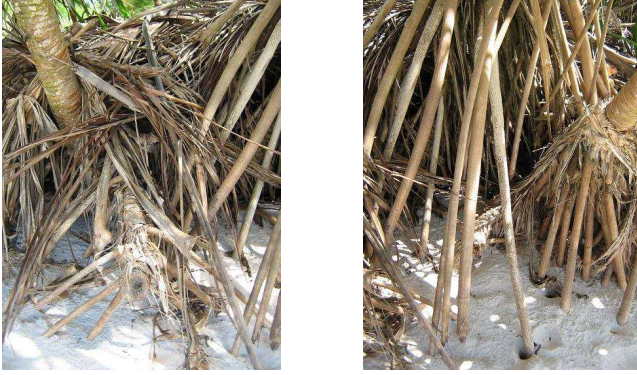
Palm trees are a more esthetical solution than mangroves. The roots of palm trees fix sand as well. The extent to which palm trees retain sediment is unknown. The effect of certain palm tree species are expected to approach the effect of mangroves, as their root systems resemble those of certain mangrove types, as shown in Figure 7-7. However, unlike mangroves, palm trees are incapable of growing in the saline intertidal area.

Figure 7-7: Palm trees with their root system

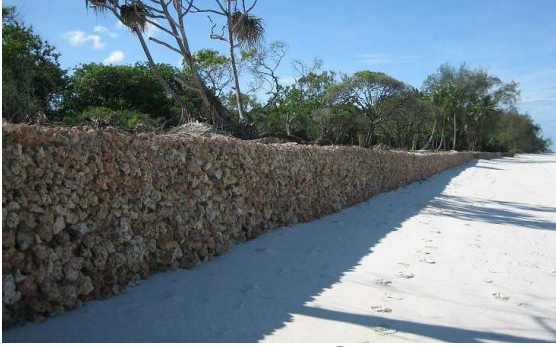
Figure 7-14: Vertical seawall in Diani Beach. Photo: CF57

Along Diani Beach most existing seawalls have not been properly built. They are often vertical (see Figure 7-14) and do not reach the required depth. In addition, a toe supporting the armour layer of a slope is lacking. Sometimes the structure fails because stability and permeability of the seawalls are not taken into account. As mentioned in paragraph 6.3.2 seawalls often collapse because a scour hole has developed in front of the seawall.

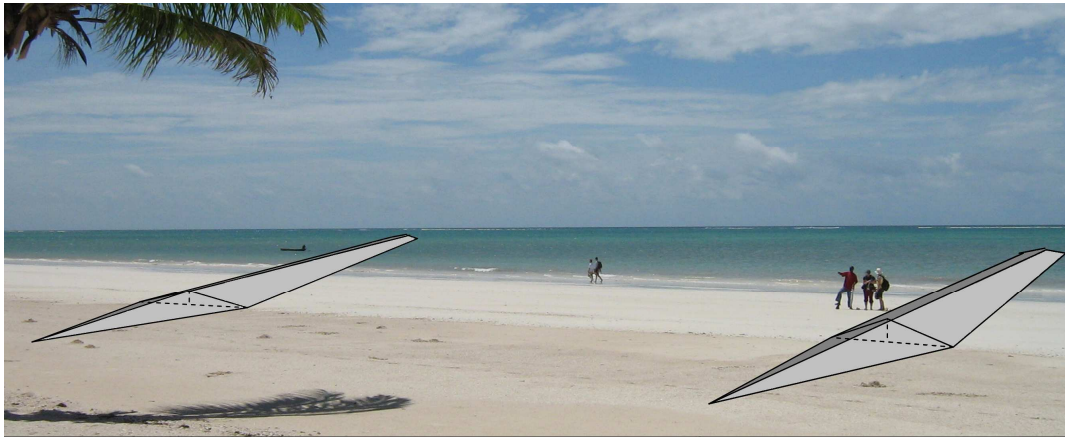
Figure 7-20: Impression of the presence of groynes in Diani Beach.

When the groynes are visible during low tide they, in particular groynes of type 2 in Figure 7-19, interrupt the present coastal landscape, which does not match the desired situation (see Figure 7-20). Another inconvenience is that people can walk on the groynes towards the sea and are exposed to the dangerous induced currents. Groynes are costly and cause scouring problems at the head of the structure.

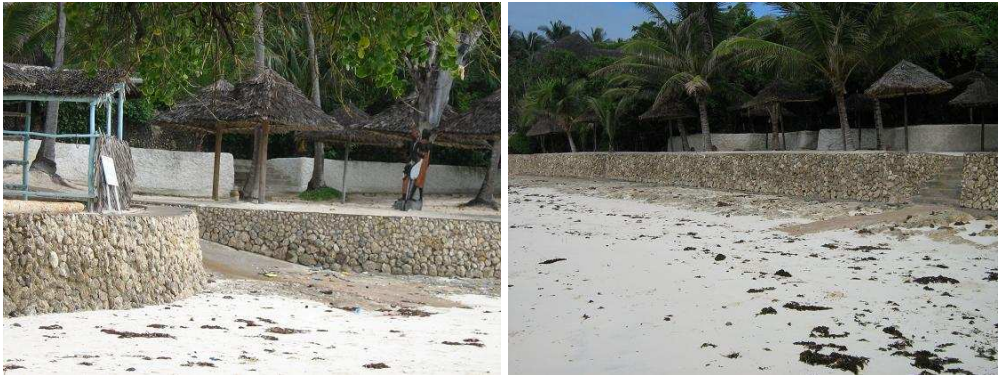
The Leopard Beach Hotel is located between big rocks; therefore it has not been affected seriously by erosion problems. Since 6 or 7 years sand has been lost, however, this sand returns. The stretch of time the sand returns and the amount of sand differs yearly. When the sand is eroded, the coral rocks emerge. Three years ago only half of the sand returned.

Figure 2: starting erosion and an elevated beach at Leopard Beach.

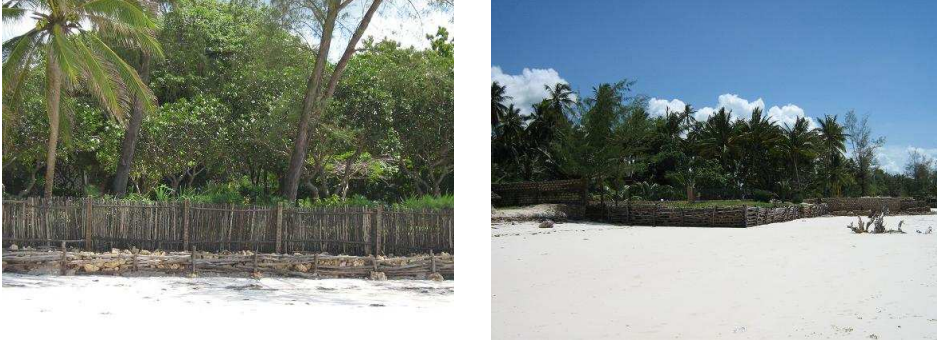
She has built two fences of horizontal wooden sticks. Right behind it she placed large rocks.

Figure 4: Structure at the private house of Luciana.

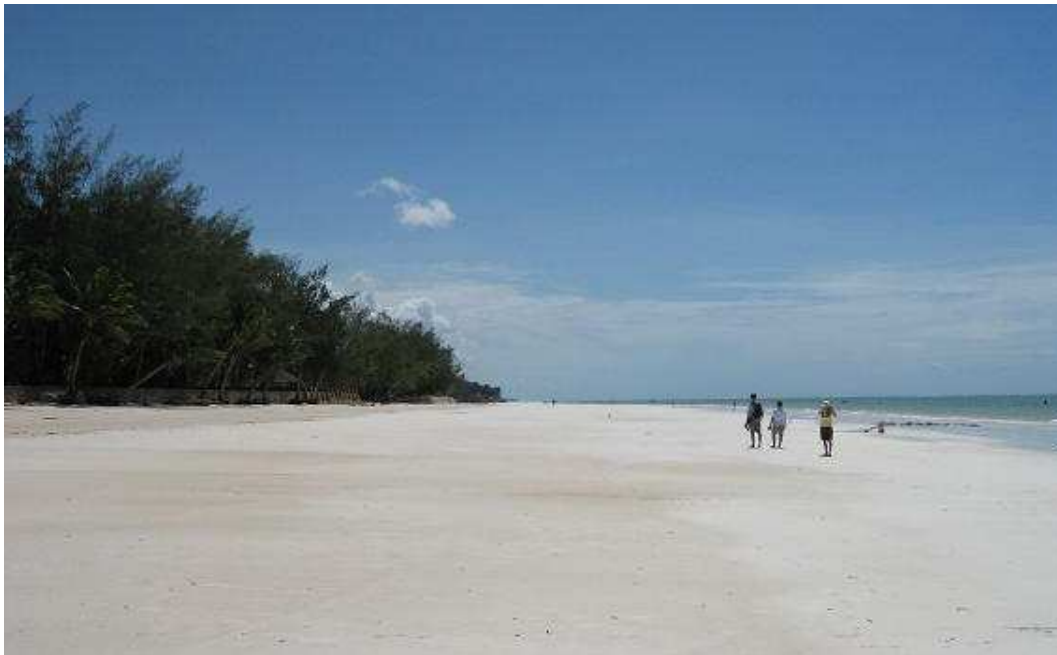
Structures on/near the beach	A protection wall is being built for Pinewood; now $\pm 0,5\text{m}$ high, $\pm 15\text{m}$ from scarp ¹ . A few other walls and small buildings (mostly canopies) are present, but not nearer than about 8m from the vegetation line. ¹ The vegetation line moved 10m landward in the last year (acc. to Pinewood)
Turbidity of the water	Quite turbid, up till 20m from the waterline
Sea grass	Hardly any sea grass on the beach

Figure 8: Section 1. Photo: CF57

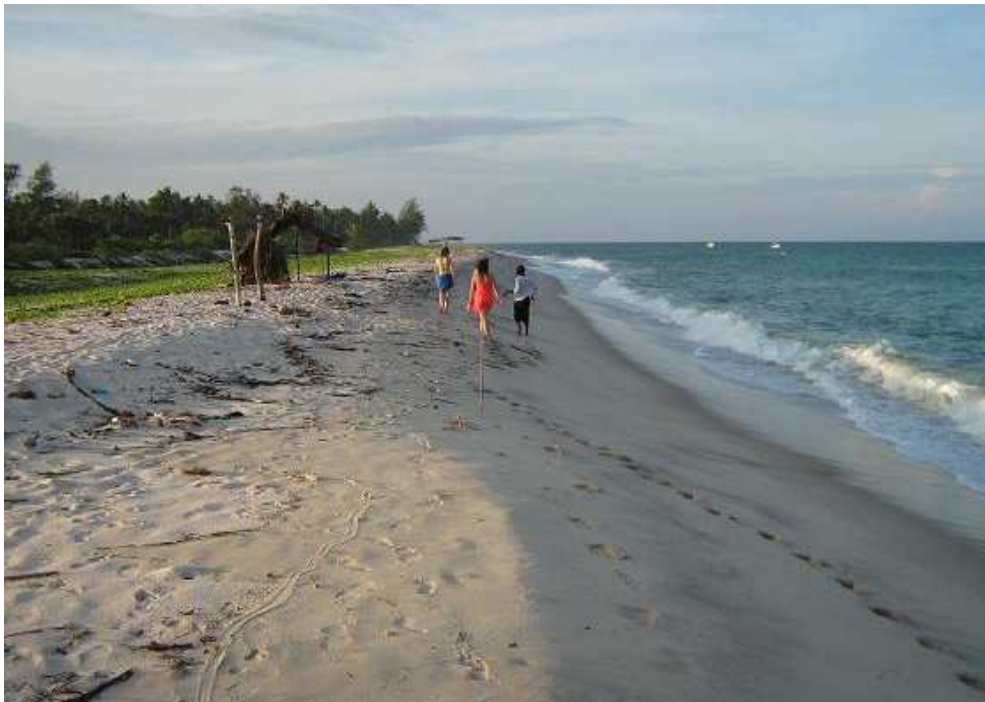
Observations and information from others
Borders	From Tiwi River up to Twiga Lodge
Hotels on this section	Tiwi Beach Resort
Time of visit	13 th of May, 17:30h
Momentary wave conditions	Plunging waves on the beach
Place of wave breaking	On the reef and on the beach
Momentary wind conditions	Quite strong; northerly
Profile	Rather steep sloping beach, 20m wide
Sediment	Coarse sand
Vegetation	Palms and grass above the high water level
Activities on/near the beach	Touristic activities (not much)
Structures on/near the beach	Small protection wall above the high water level; $\pm 30\text{cm}$
Turbidity of the water	Turbid for about 30m from the waterline
Sea grass	Little sea grass on the beach

Figure 25: Section 16. Photo: CF57

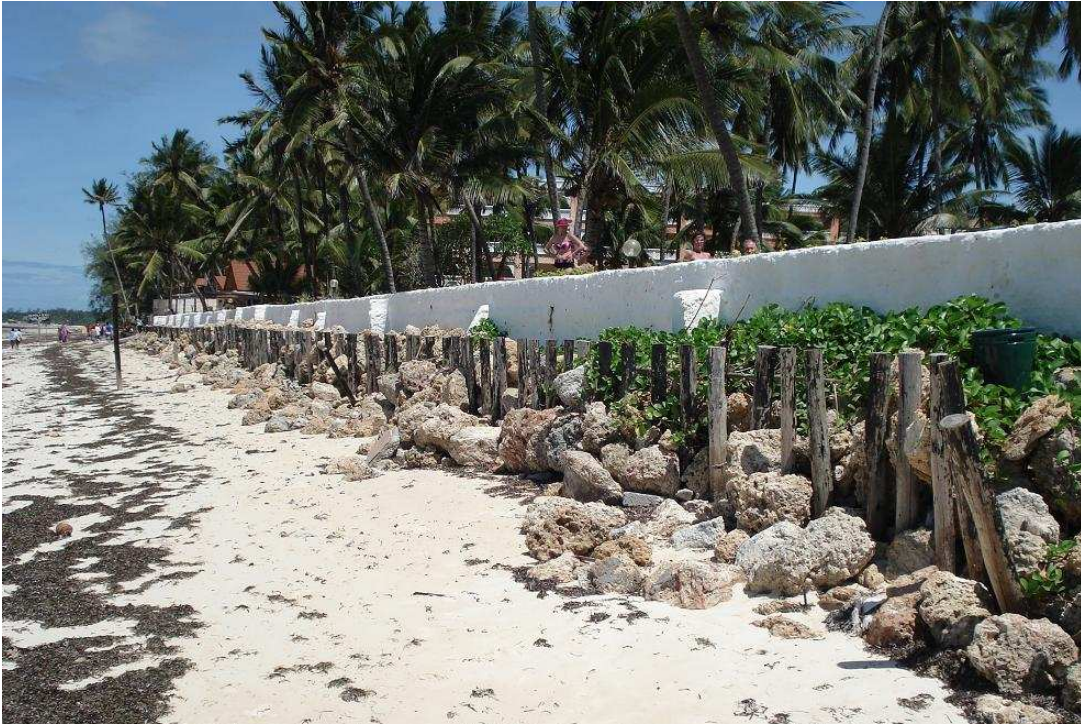
Figure 26: Section 2, seawall at Sun N Sand Beach Resort. Photo: CF57

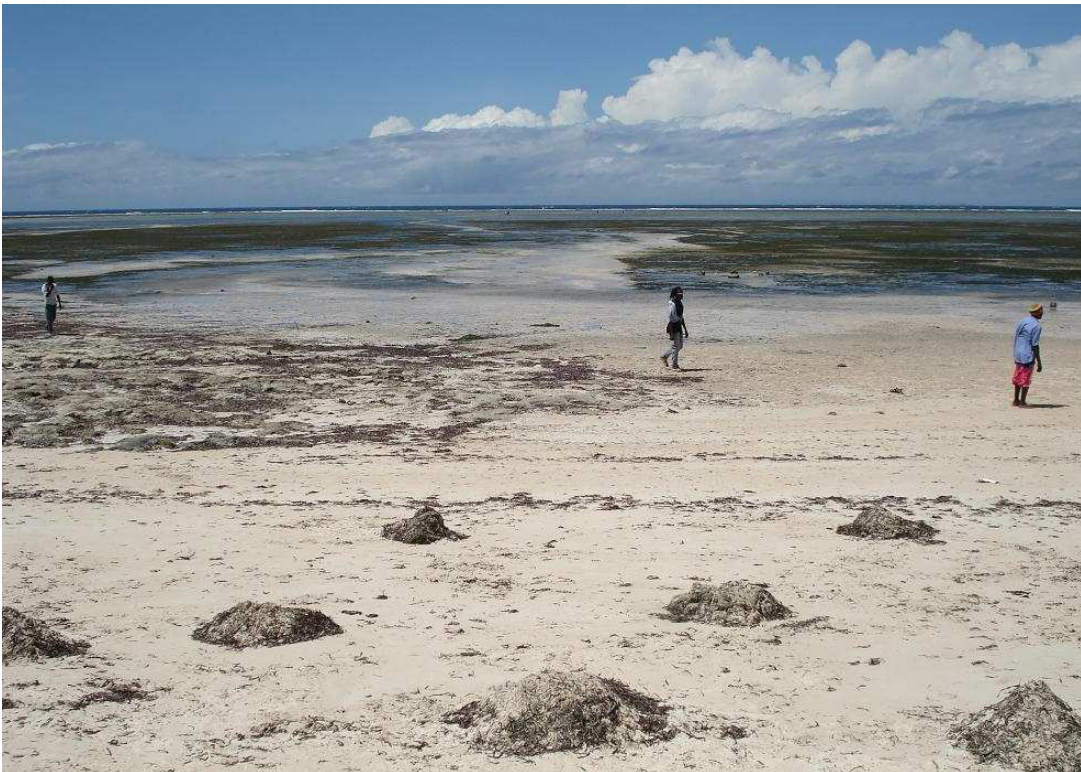
Figure 27: Section 2, low tide, paths to the coral reef and sea grass visible. Photo: CF57

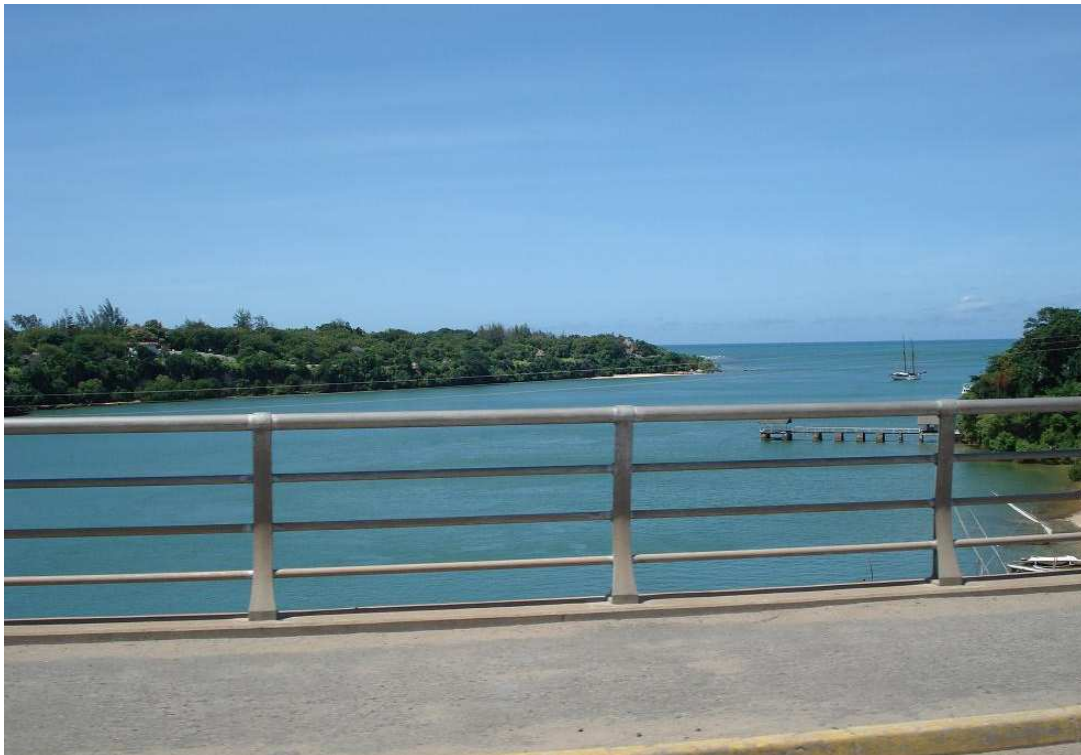
May 12, 2006	Observations
Hotels on this section	No hotels
Time of visit	± 14.00
Momentary wave conditions	Not applicable
Place of wave breaking	Not applicable
Momentary wind conditions	Not applicable
Profile	Not applicable
Sediment	No sediment in the inlet, there is no large river flowing out of the river.
Vegetation	
Activities on/near the beach	In the inlet there a many fishery activities. Fishermen fish in the sea near mouth of the inlet. In the inlet there are also many recreational activities.
Structures on/near the beach	Rocky coast, no structures
Turbidity of the water	The water is quite clear.
Sea grass	Not applicable

Figure 28: Section 3, Kilifi Creek. Photo: CF57

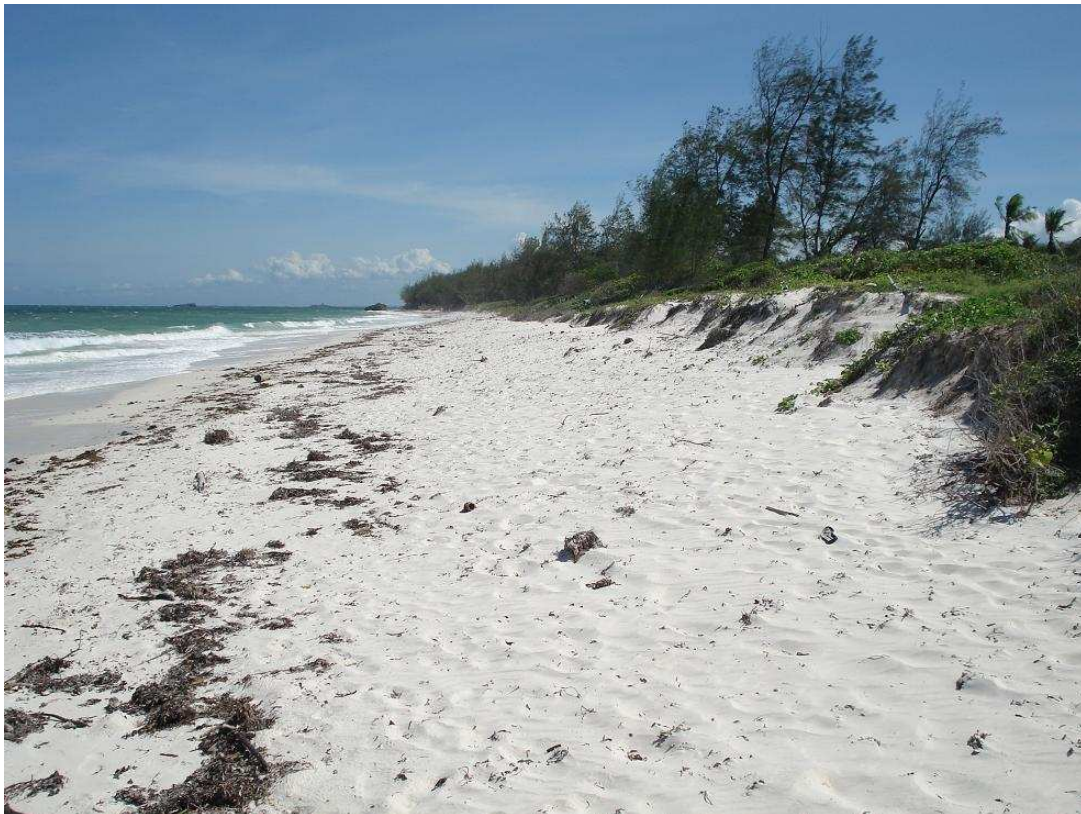
May 12, 2006	Observations
Hotels on this section	Malob Guest House
Time of visit	15.00h
Momentary wave conditions	-
Place of wave breaking	Wave break far out the coast on the coral reef, about 1 km out of the coast.
Momentary wind conditions	Strong wind for the sea.
Profile	A flat, short stretched beach.
Sediment	Very white sand
Vegetation	Mangroves and sea creeper.
Activities on/near the beach	There is a Marine park near the coast, besides that there are touristic activities.
Structures on/near the beach	No structures on the beach.
Turbidity of the water	Clear water.
Sea grass	Some sea grass on the beach

Figure 29: Section 4, Watamu. Photo: CF57

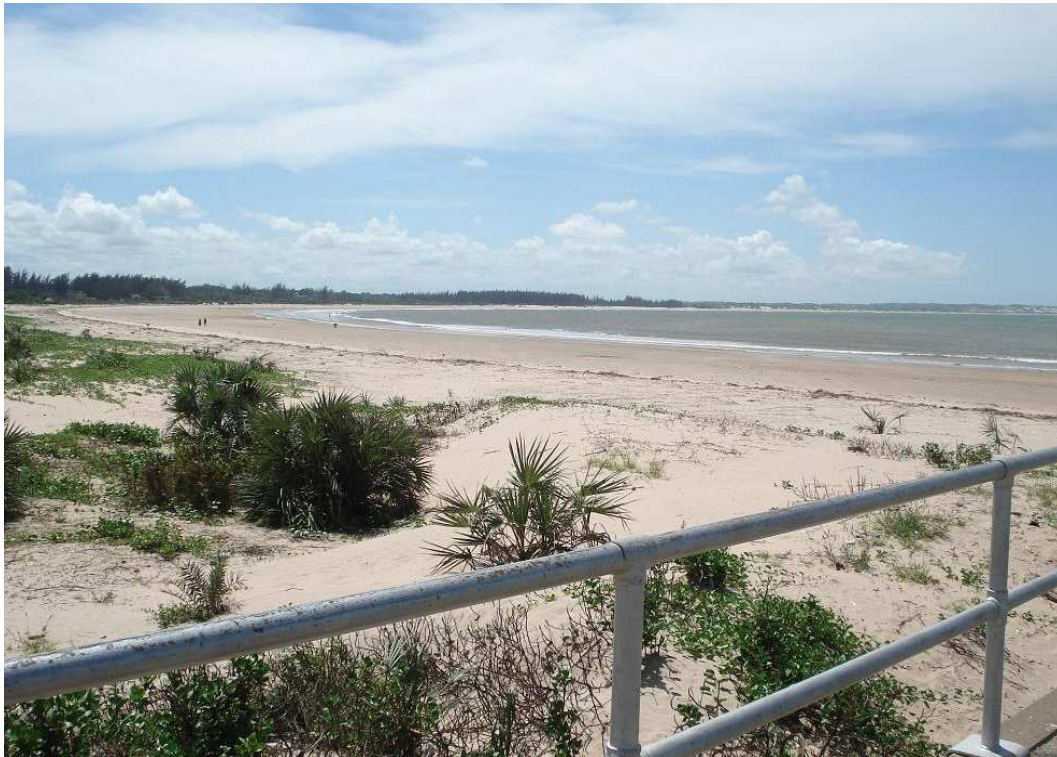
May 13, 2006	Observations
Hotels on this section	More to the north there are beach resorts.
Time of visit	14.00h
Momentary wave conditions	-
Place of wave breaking	Waves break on the beach
Momentary wind conditions	-
Profile	Very wide beaches (500 to 1000 m). On the beach between the old seawall and the sea little dunes are present.
Sediment	The sand on the beach is white, but there is also river sand present.
Vegetation	On the beach near the road sea grass is present.
Activities on/near the beach	The main activities on and near the beach are fishing and tourism.
Structures on/near the beach	There is a seawall on the beach. This seawall is build in the sixties, this was ones a sea defence, but now the seawall is 600 meter from the sea and there is a long beach in front of the seawall.
Turbidity of the water	The water is clear
Sea grass	No sea grass

Figure 30: Section 5, a lot of accretion at Malindi. Photo: CF57

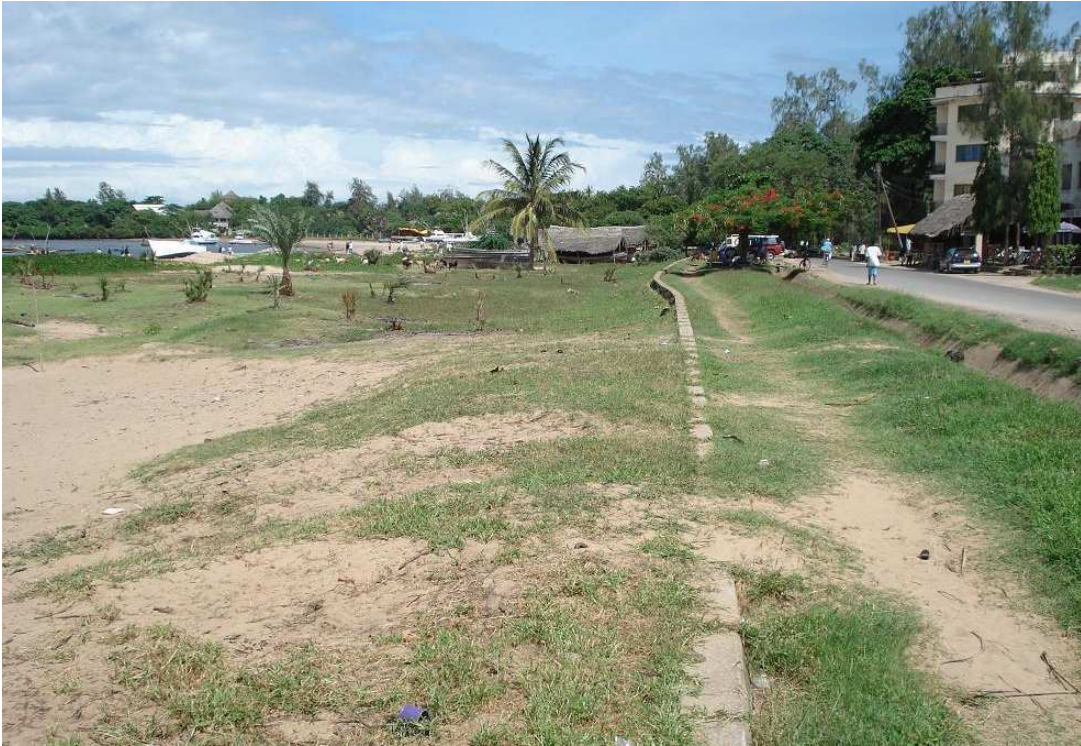
Figure 31: Section 5, old seawall. Photo: CF57

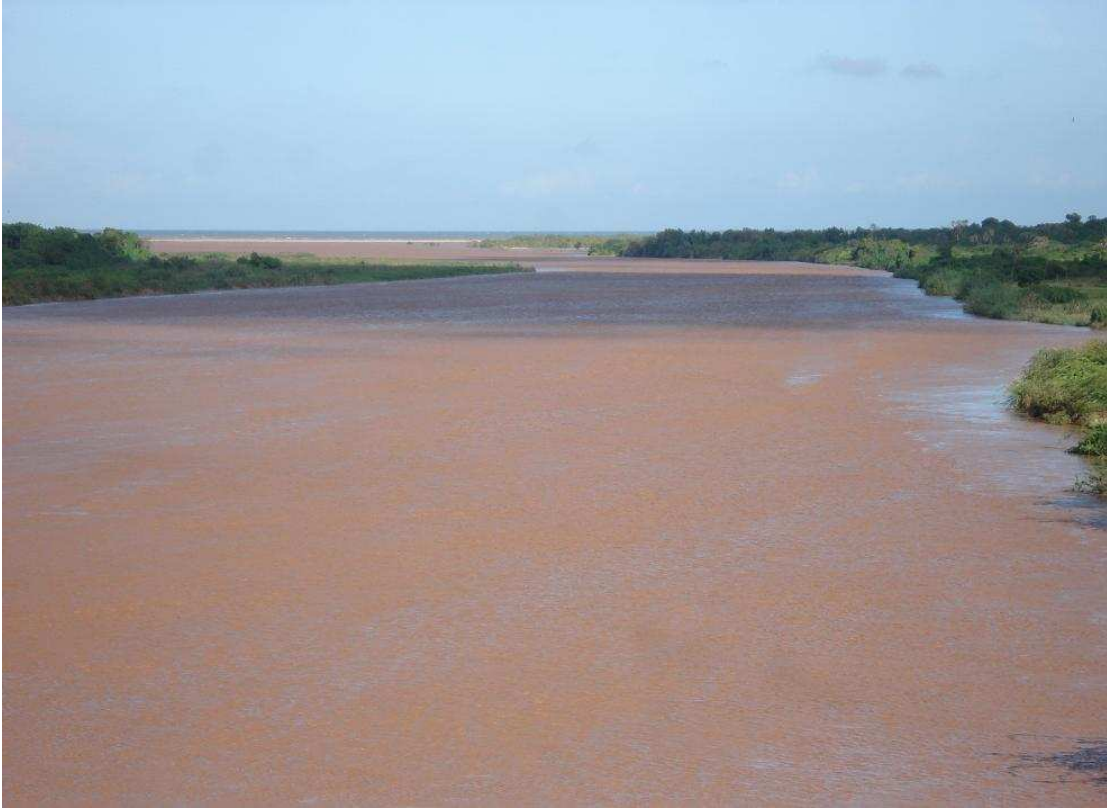
The Sabaki River is a monsoon river. During the rain period a lot of sediment is taken to the sea by this river. At the end of July this bridge is crossed again, at that time the river was almost completely dry mud banks are present in the river bed. Unfortunately no pictures could be made.

Figure 32: Section 6, Sabaki River. Photo: CF57

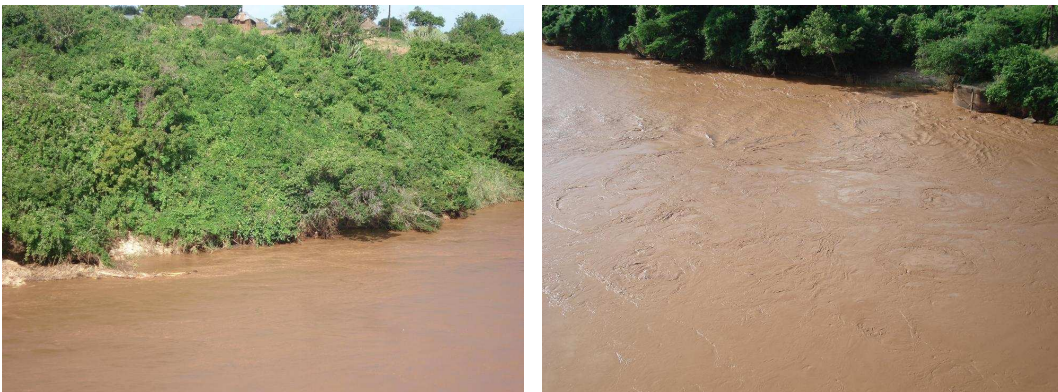
Figure 33: Section 6, closer view of the sediment in the Sabaki River. Photo: CF57

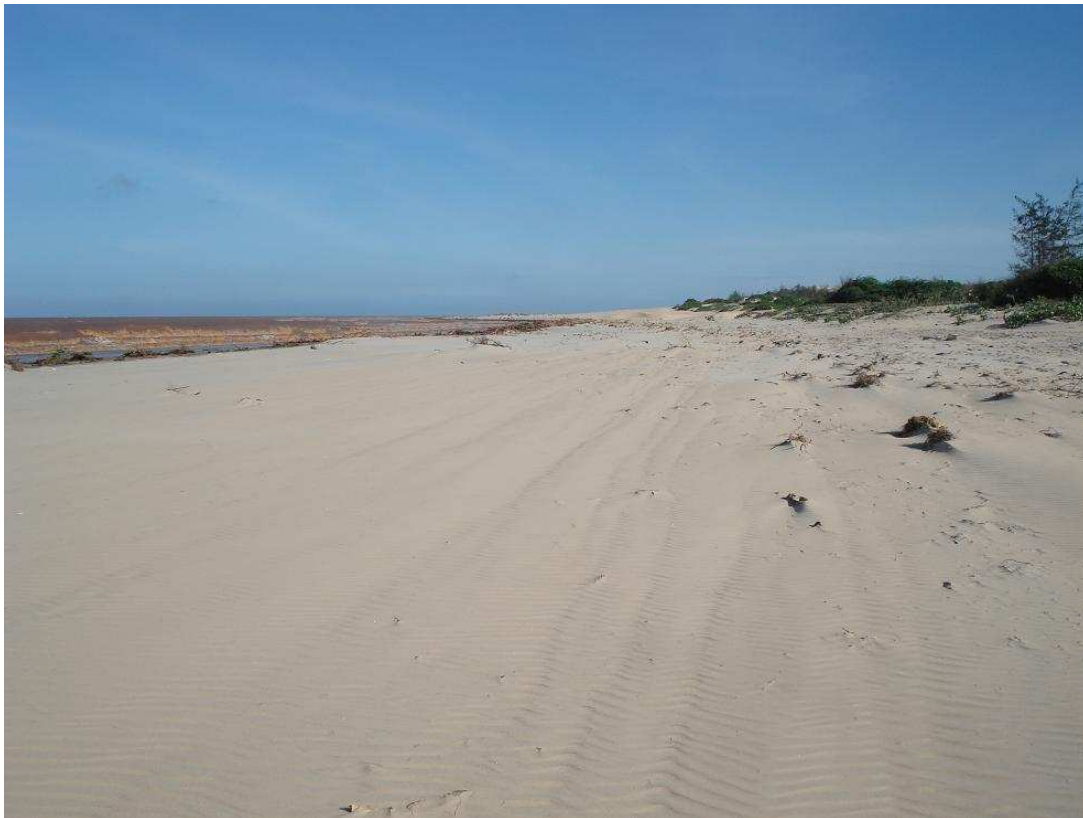
May 12, 2006	Observations
Hotels on this section	-
Time of visit	17.00h
Momentary wave conditions	
Place of wave breaking	Waves break on the coast.
Momentary wind conditions	Strong wind from the south.
Profile	Sand dunes, than a long very flat, stretched beach.
Sediment	The sea water was red/ brown, because of sand. The beaches were covered with white sand, but 5 cm deep darker sand can be found.
Vegetation	On the sand dunes there are sea creepers.
Activities on/near the beach	There are no activities on the beach.
Structures on/near the beach	There are no structures on the beach.
Turbidity of the water	The water is very muddy.
Sea grass	No sea grass

Figure 34: Section 7, sand dunes at Mambrui. Photo: CF57

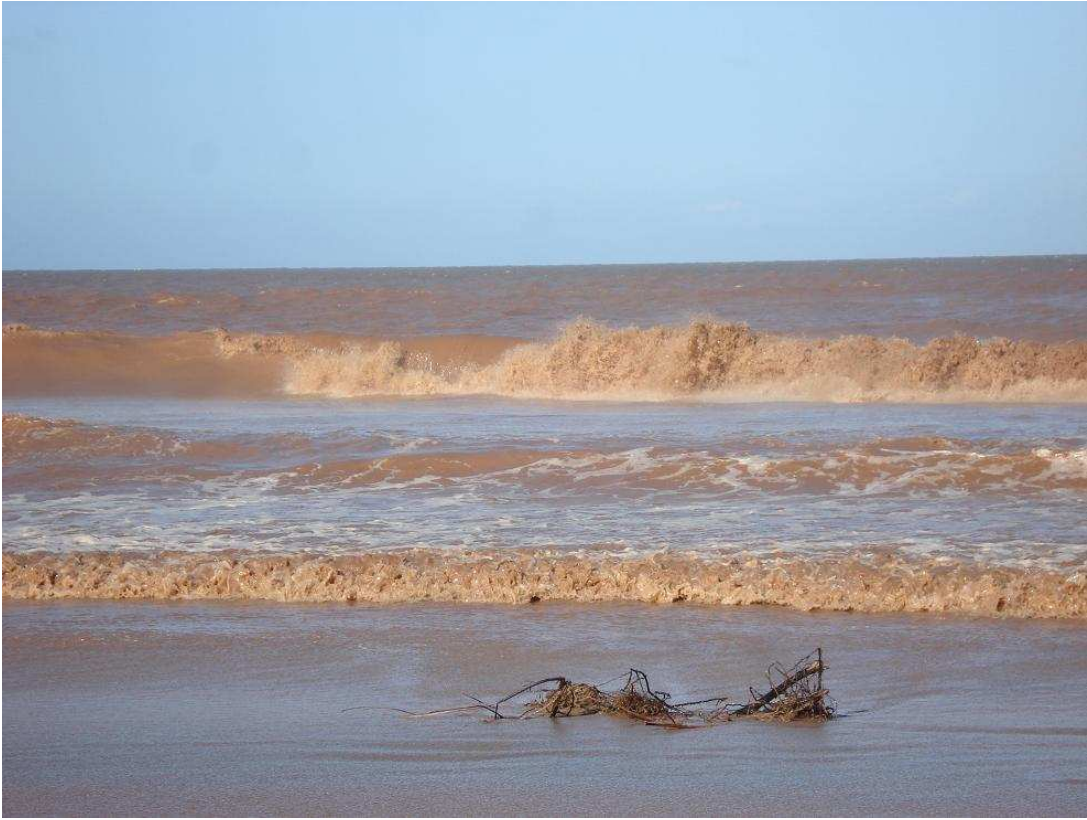
Figure 35: Section 7, brown sea caused by the sediment of the Sabaki River. Photo: CF57
